# Manhole Inspection Summary

Manhole # S43EE\_031MH

Insp Date: **3/10/08 1:50 PM**

**Location** Address: **1001 BOND ST**

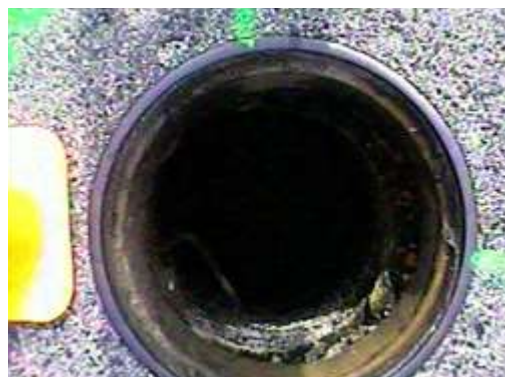
Defect 1

Offset: **2** (in.)

Condition: ☐ Sound ☐ Cracked ☐ Root Intrusion ☒ **Loose Brick** ☐ Deteriorated

CHIMNEY LOOSE BRICKS AND FRAME OFFSET

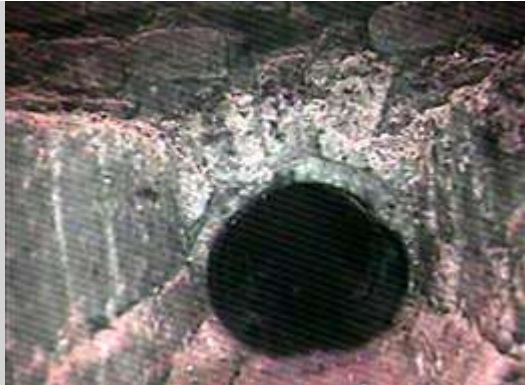
12 O'Clock Outflow

8 in. Circular Gravity Sewer  
Pipe Out @ 12 O'Clock

Pipe Material: **Clay** ☐ Pipe Lined

Invert Depth: **11.54** (ft.) Flow Characteristics: **Fast**

Infiltration: **None** Pipe Seal Cond: **Sound**

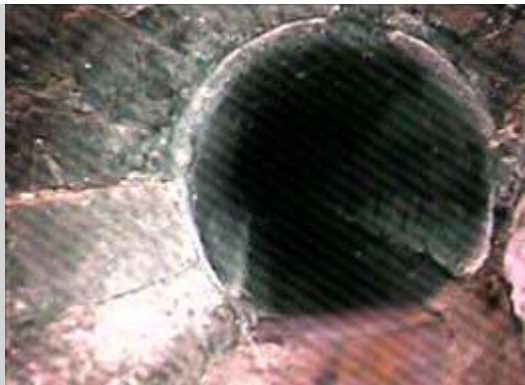
3 O'Clock Inflow

8 in. Circular Gravity Sewer  
Pipe In @ 3 O'Clock

Pipe Material: **Clay** ☐ Pipe Lined

Invert Depth: **11.11** (ft.) Flow Characteristics: **Fast**

Infiltration: **None** Pipe Seal Cond: **Cracked**

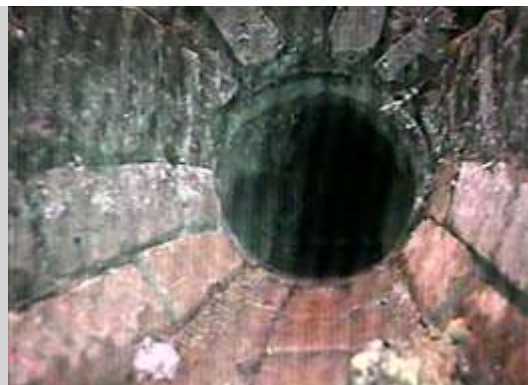
6 O'Clock Inflow

8 in. Circular Gravity Sewer

Pipe In @ 6 O'Clock

Pipe Material: **Clay** ☐ Pipe Lined

Invert Depth: **11.53** (ft.) Flow Characteristics: **Fast**

Infiltration: **None** Pipe Seal Cond: **Sound**
